COMPLETE SOLUTION
GENUINE QUALITY

Air Intake Hose

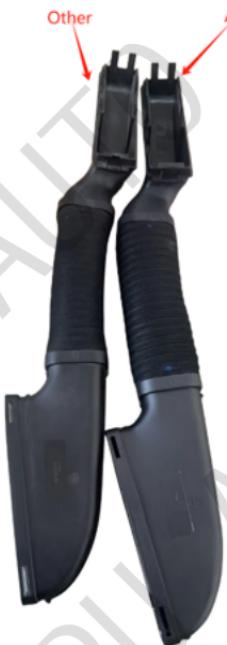
1. The plastic material is the same PPS.
2. The length from other suppliers differs from the original dimensions.

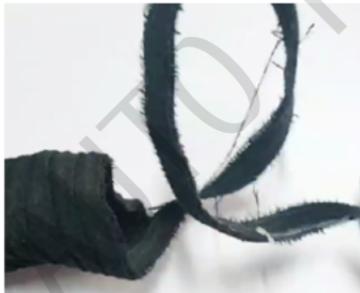
AP

- 1.AP:** After breaking, the fabric remains normal.
- 2.Other:** After breaking, the fabric gets tangled together.
- 3.Poor:** Breaks with minimal pull, but the fabric remains normal after breaking.
